Subj: VP-74 AAR ser 3-62 concerning F-4B (F4H-1) BuNo 148374  
accident occurring 27 October 1962, pilot (b) (6)

PIFTH ENDORSEMENT on VF-74 AAR 3-62, F4B, 148374, accident occurring  
27 October 1962, pilot (b) (6)

PHOTOGRAPH Enclosure (6) VF-74 uR 3-62 F-4B (F4H-1) BuNo 148374

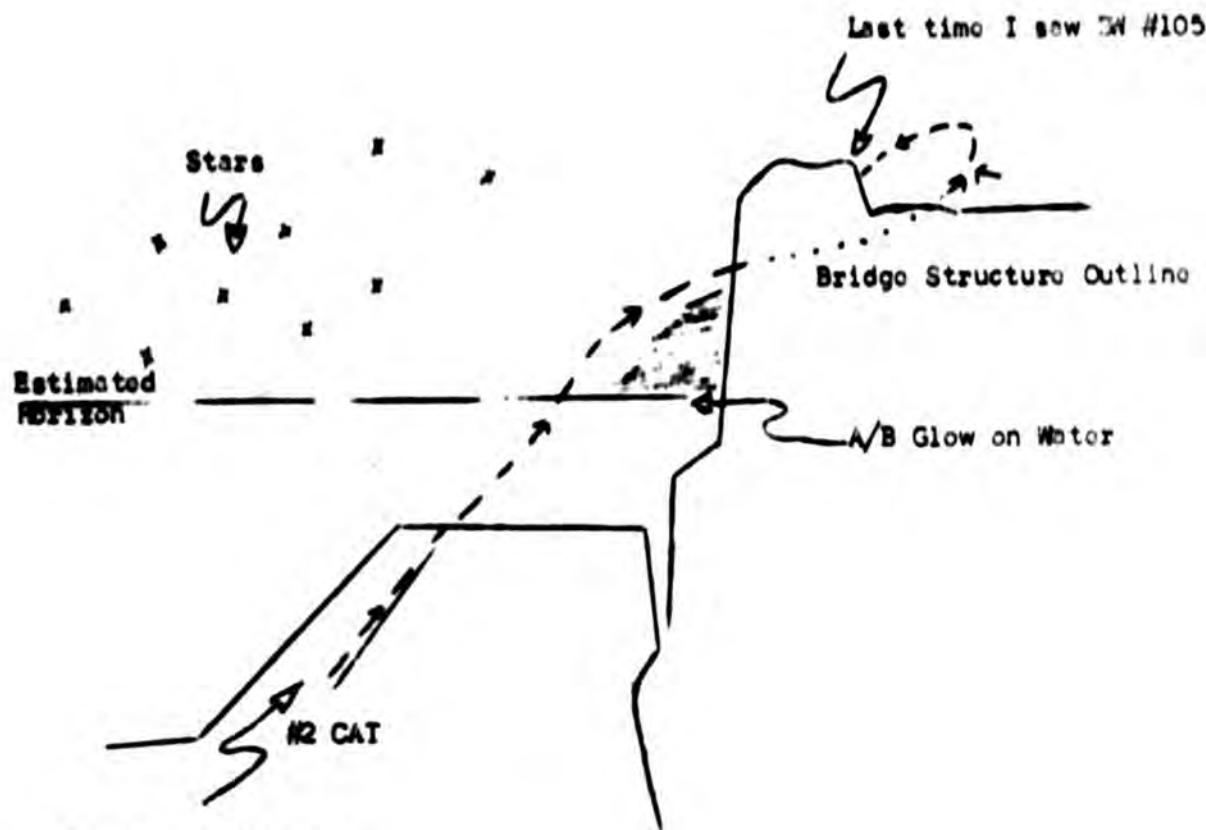
Rough flight path of BW #105 as viewed from Pri-Fly.

1. Flaps Full Down
2. Stick Aft
3. Wing & Tail Lights  
Dim & Steady
